# NATIONAL BUREAU OF STANDARDS REPORT

QUARTERLY REPORT FOR THE PERIOD ENDING JUNE 30, 1967 ON

INVESTIGATION OF THE DIRECTIONAL EFFECTS  
IN THE STRESS CORROSION OF ALUMINUM ALLOYS

National Aeronautics and Space Administration  
George C. Marshall Space Flight Center  
Huntsville, Alabama

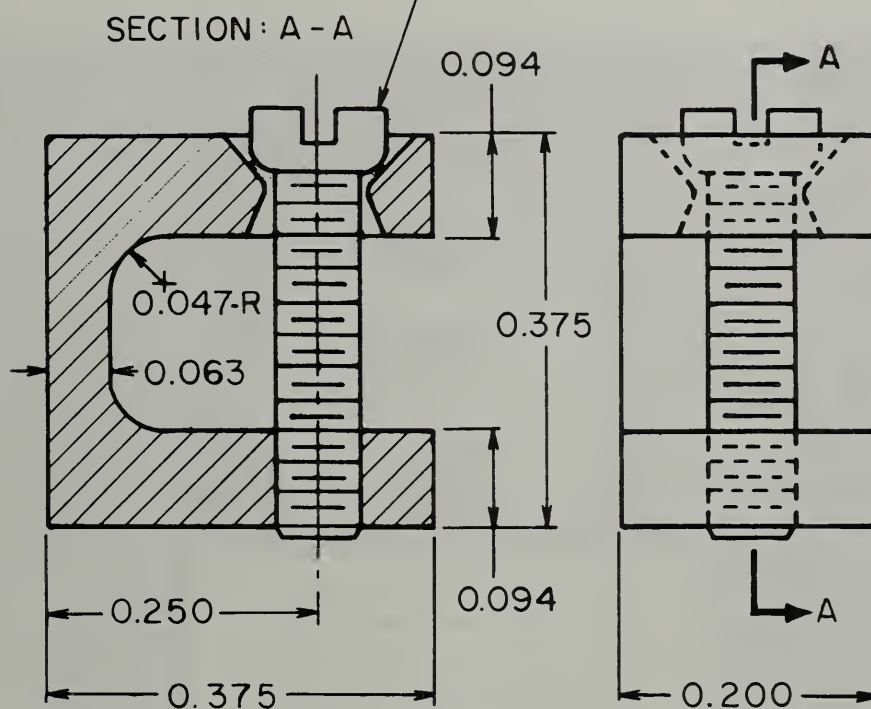
# MINIATURE TUNING FORK STRESS-CORROSION SPECIMEN

3-48 MACHINE SCREW  
(WITH SHOULDER ROUNDED)

ALL DIMENSIONS IN INCHES  
TOLERANCE  $\pm 0.001$  THROUGHOUT

Figure 1. Miniature specimen design used in scanning electron microscope studies.

The specimen used for the crack initiation studies (Figure 1) was designed specifically to fit into the specimen chamber of a scanning electron microscope. The specimens were extracted from the center of the 7075-T651 plate such that the stressed face was in the short transverse-longitudinal plane and the stress direction parallel to the longitudinal direction. This particular orientation was chosen because it is the grain morphology most immune to stress corrosion cracking, and is ideal for observing crack initiation in an elongated grain structure.

A small strain gage was then attached to the surface of the specimen to be stressed so that the relationship between strain and deflection at the screw could be obtained. After obtaining the strain-deflection curve, the stress-deflection curve was plotted with the help of previously obtained stress-strain curves. Other specimens were then stressed to 75% Y.S. (0.2% offset) (56,500 psi) and masked to have only a 2mm square area exposed (Figure 2) to the corrodent. These specimens were then corroded for various times from 30 seconds to 16 hours in the chromate solution. Surface features were then observed in a scanning type electron microscope.\*\*

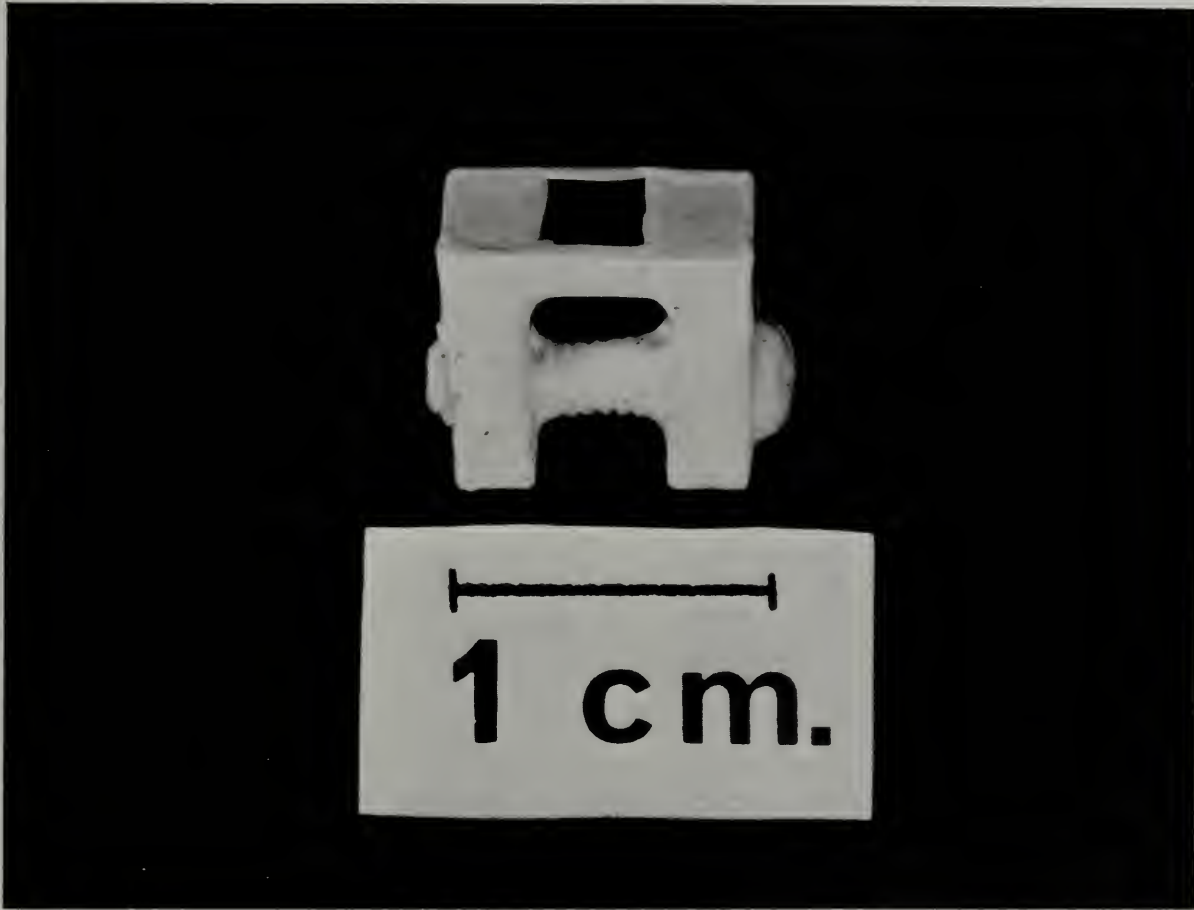
Figure 2. Masked-off miniature tuning fork specimen.

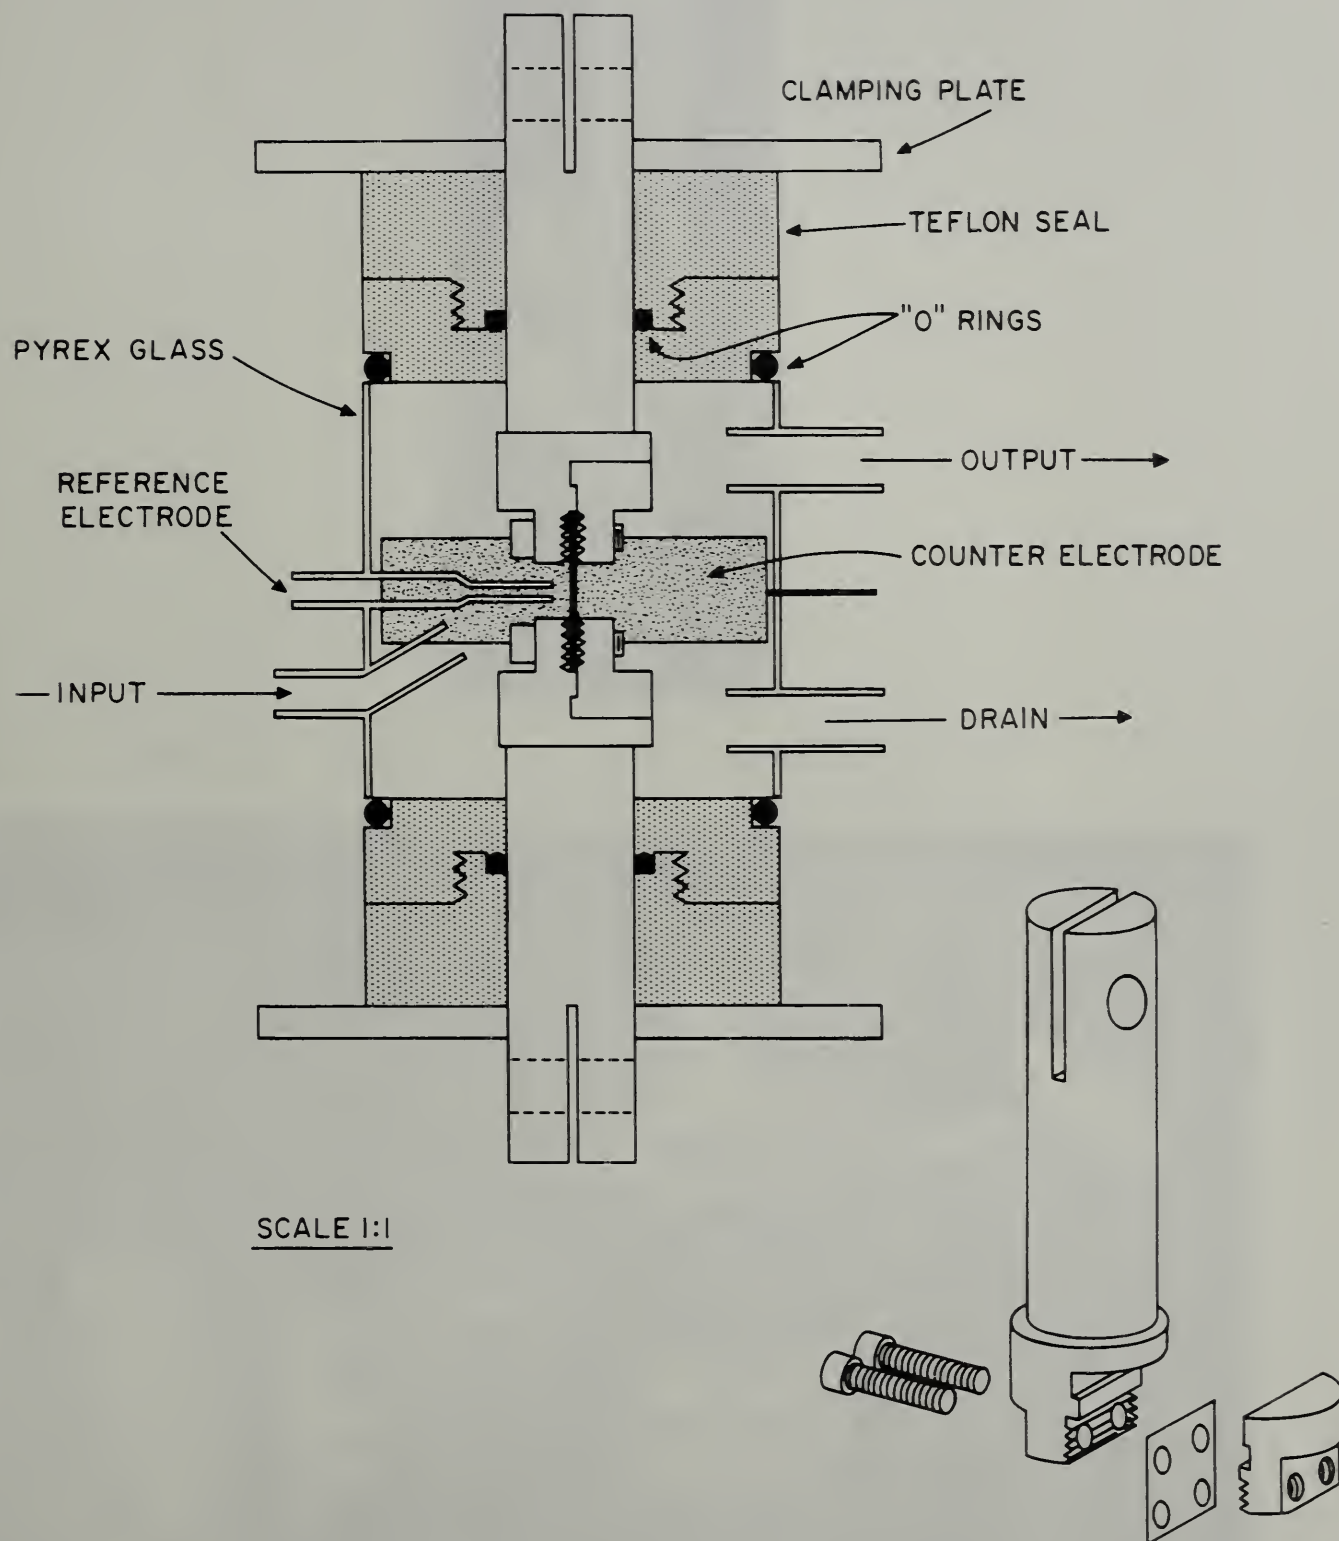
Figure 3. Initial electrochemical stress corrosion cell design for externally applied stress on square specimens.

Two specimen designs were used: 1) 0.75 x 0.75 x 0.030-inch square specimens (Figure 3), capable of being stressed parallel to either axis in a given plane; 2) tuning fork specimen (Figure 4a) with a 0.375 x 0.500-inch face. In each instance, specimens were machined from the center portion of the plate in order to eliminate those effects resulting from the variation in stress corrosion susceptibility with plate

Square specimens were clamped in a stainless steel bracket (Figure 3) and all but an 1/8-inch square area in the center of the specimen coated with electroplater's stop-off lacquer. Tuning fork specimens were stressed before mounting in the support bracket and coated with stop-off lacquer. Specimen assemblies were then placed in the appropriate electrochemical cell (Figures 3, 4b, and 5).

Two cell systems were used during the course of the investigation. The initial design consisted of a pyrex glass body with a built-in Luggin capillary and platinized platinum counter electrode. The cell was later modified so that self-stressed tuning fork specimens could be used. In addition, the Luggin capillary of the reference electrode could be positioned to within 0.1mm of the specimen surface to minimize IR drop in the electrolyte. The potential of the specimen surface was maintained at a selected value by means of a potentiostat. Current measurements were then made as a function of specimen potential. During the course of exposure, the corrodent ( $500 \text{ cm}^3$ ) was circulated at a constant flow rate of  $600 \text{ cm}^3$  per minute and directed at the specimen surface to sweep away gas bubbles which would interfere with current measurements.

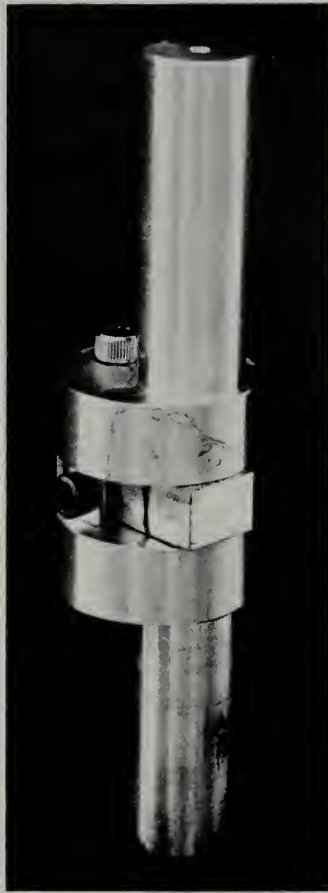
Figure 4a. Tuning fork specimen in mounting bracket.

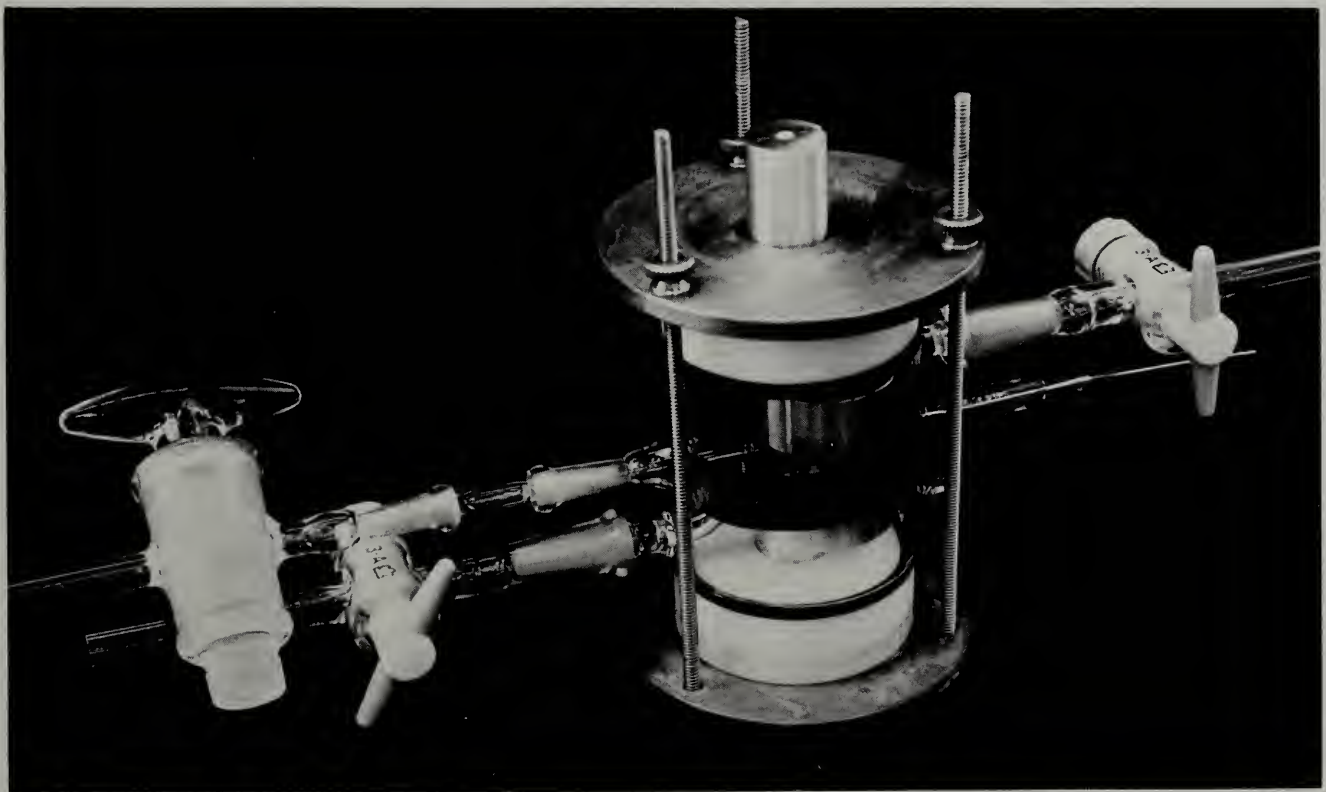
Figure 4b. Assembled electrochemical stress corrosion cell for self-stressed tuning fork specimens.

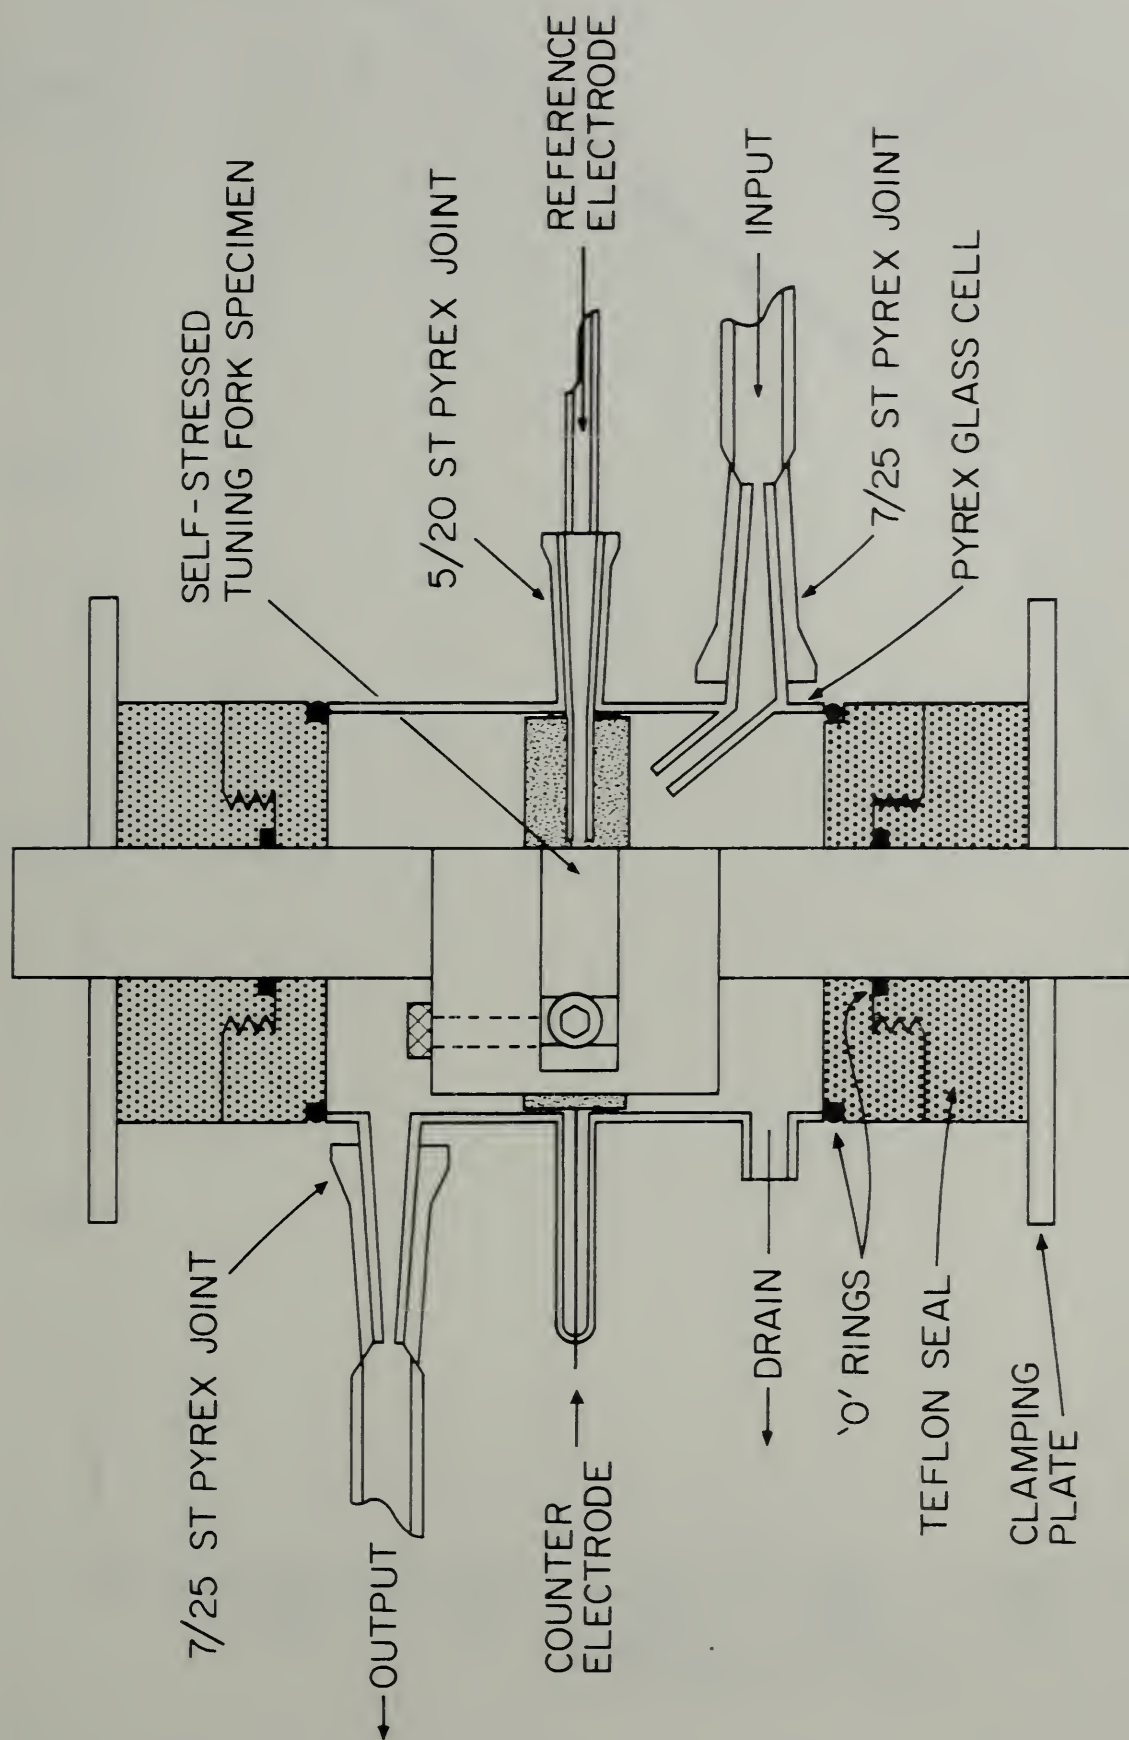
Figure 5. Final electrochemical stress corrosion cell design for self-stressed tuning fork specimens.

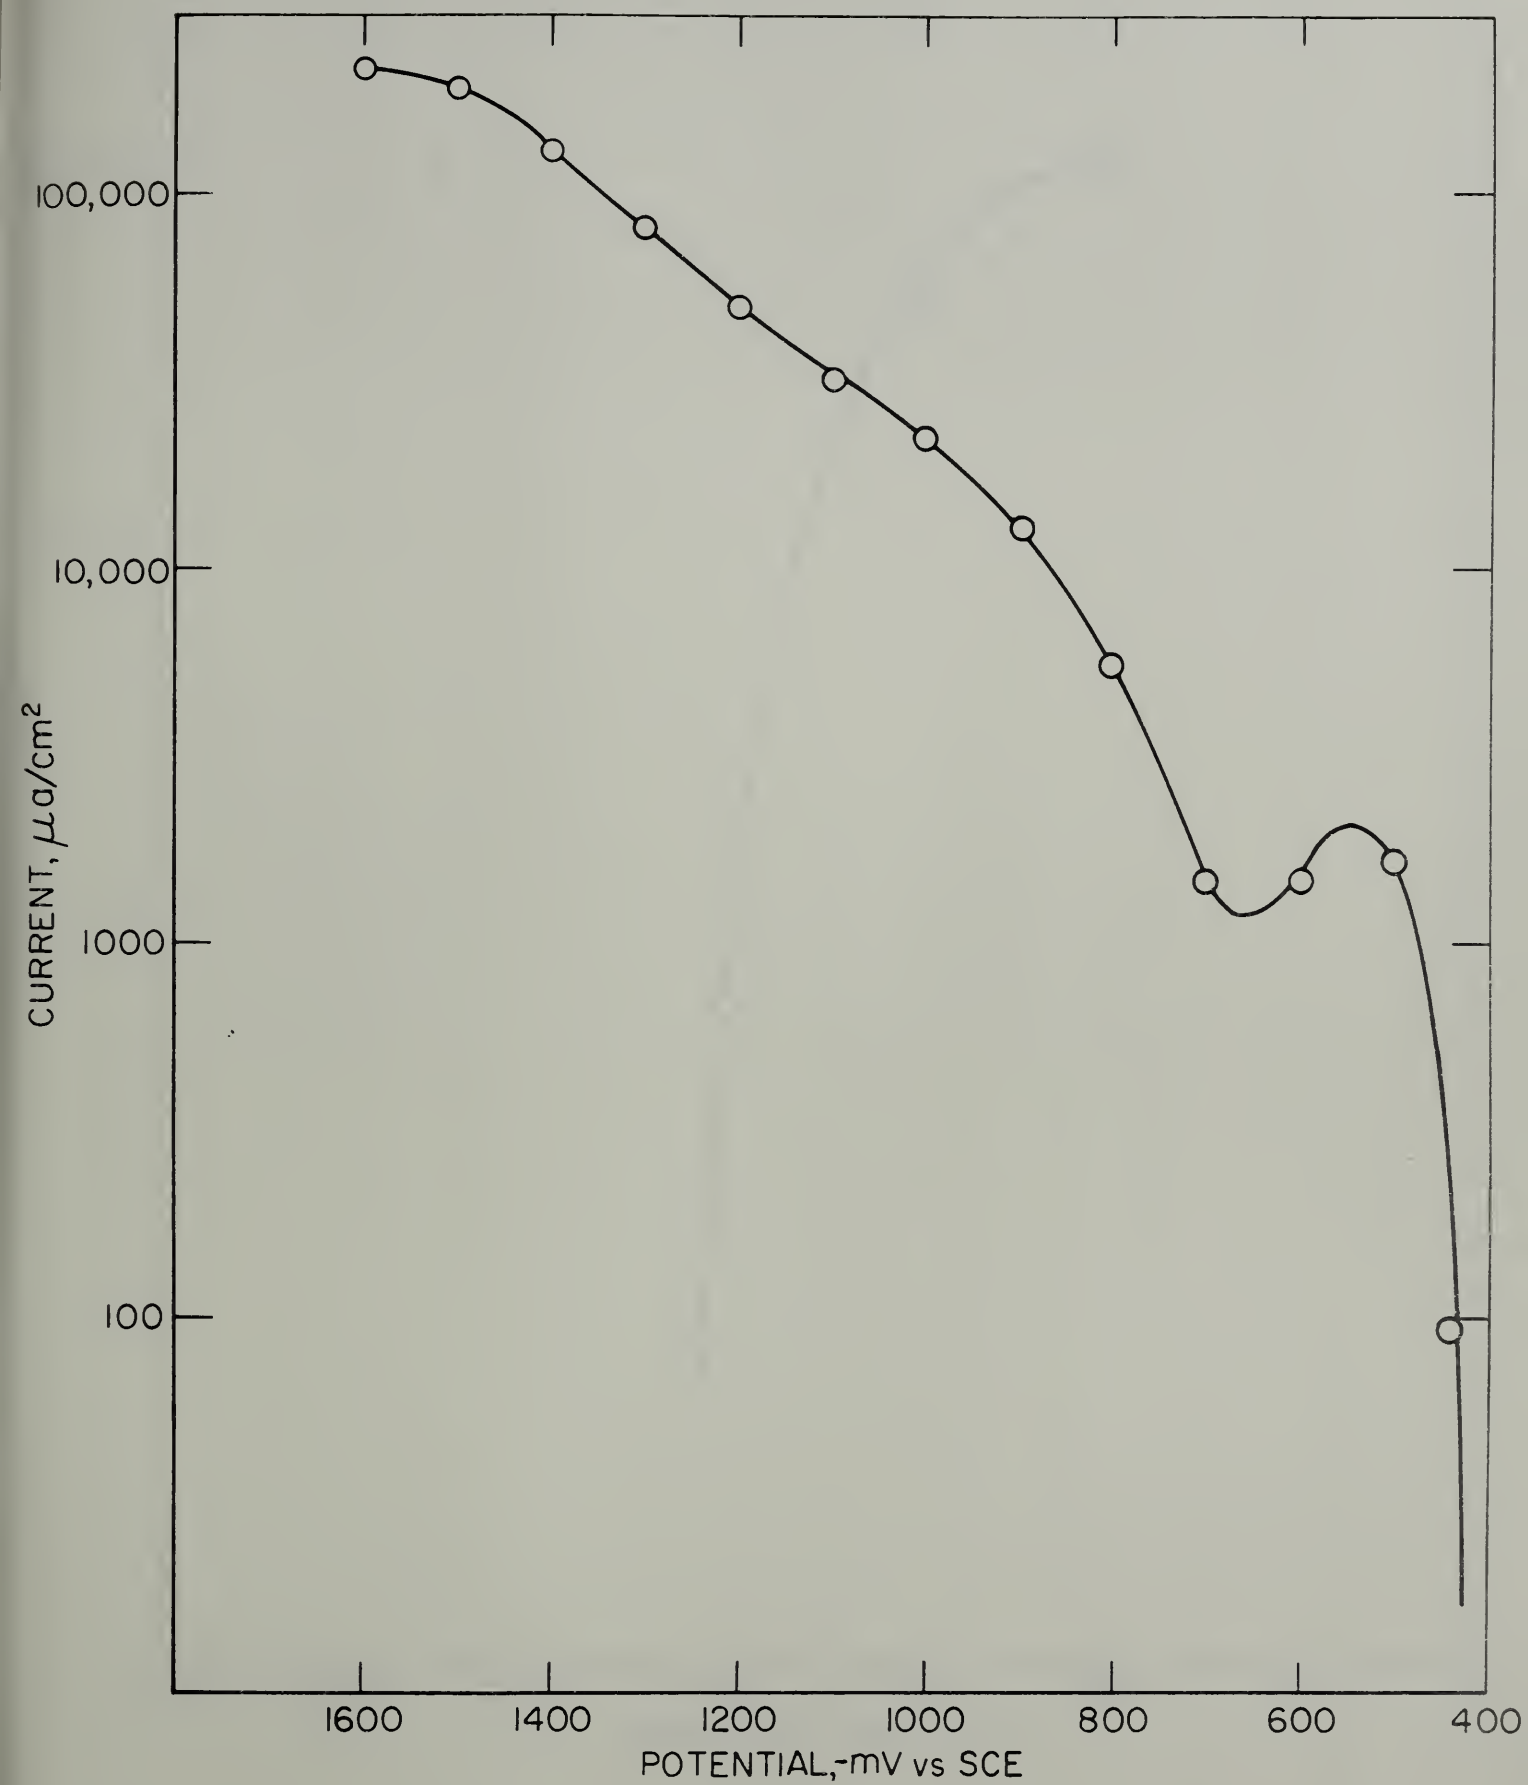
FIGURE 6. CATHODIC POLARIZATION CURVE FOR 7075-T651 IN 0.3% NaCl - 3.0%  $K_2Cr_2O_7$  - 3.0%  $CrO_3$ . OPEN CIRCUIT EMf = -440 mV vs SCE.

Polarization curves were constructed for the 7075-T651 alloy in each of the environments previously described. The potential was varied in both an anodic as well as a cathodic direction, and current readings were made only after a steady state value was reached. At least three sets of data were obtained in each environment. The curves obtained are shown in Figures 6 through 11.

Figures 6 through 11 are the polarization curves for the 7075-T651 alloy in chromate environment, 3.5% sodium chloride, and the 1.0N sodium nitrate solutions. The obtaining of these curves is the first step in our electrochemical studies of the role of directionality on mechanism of cracking. The open circuit potentials are labeled on these curves for the chromate and for the chloride solutions and cracking does occur at these potentials.

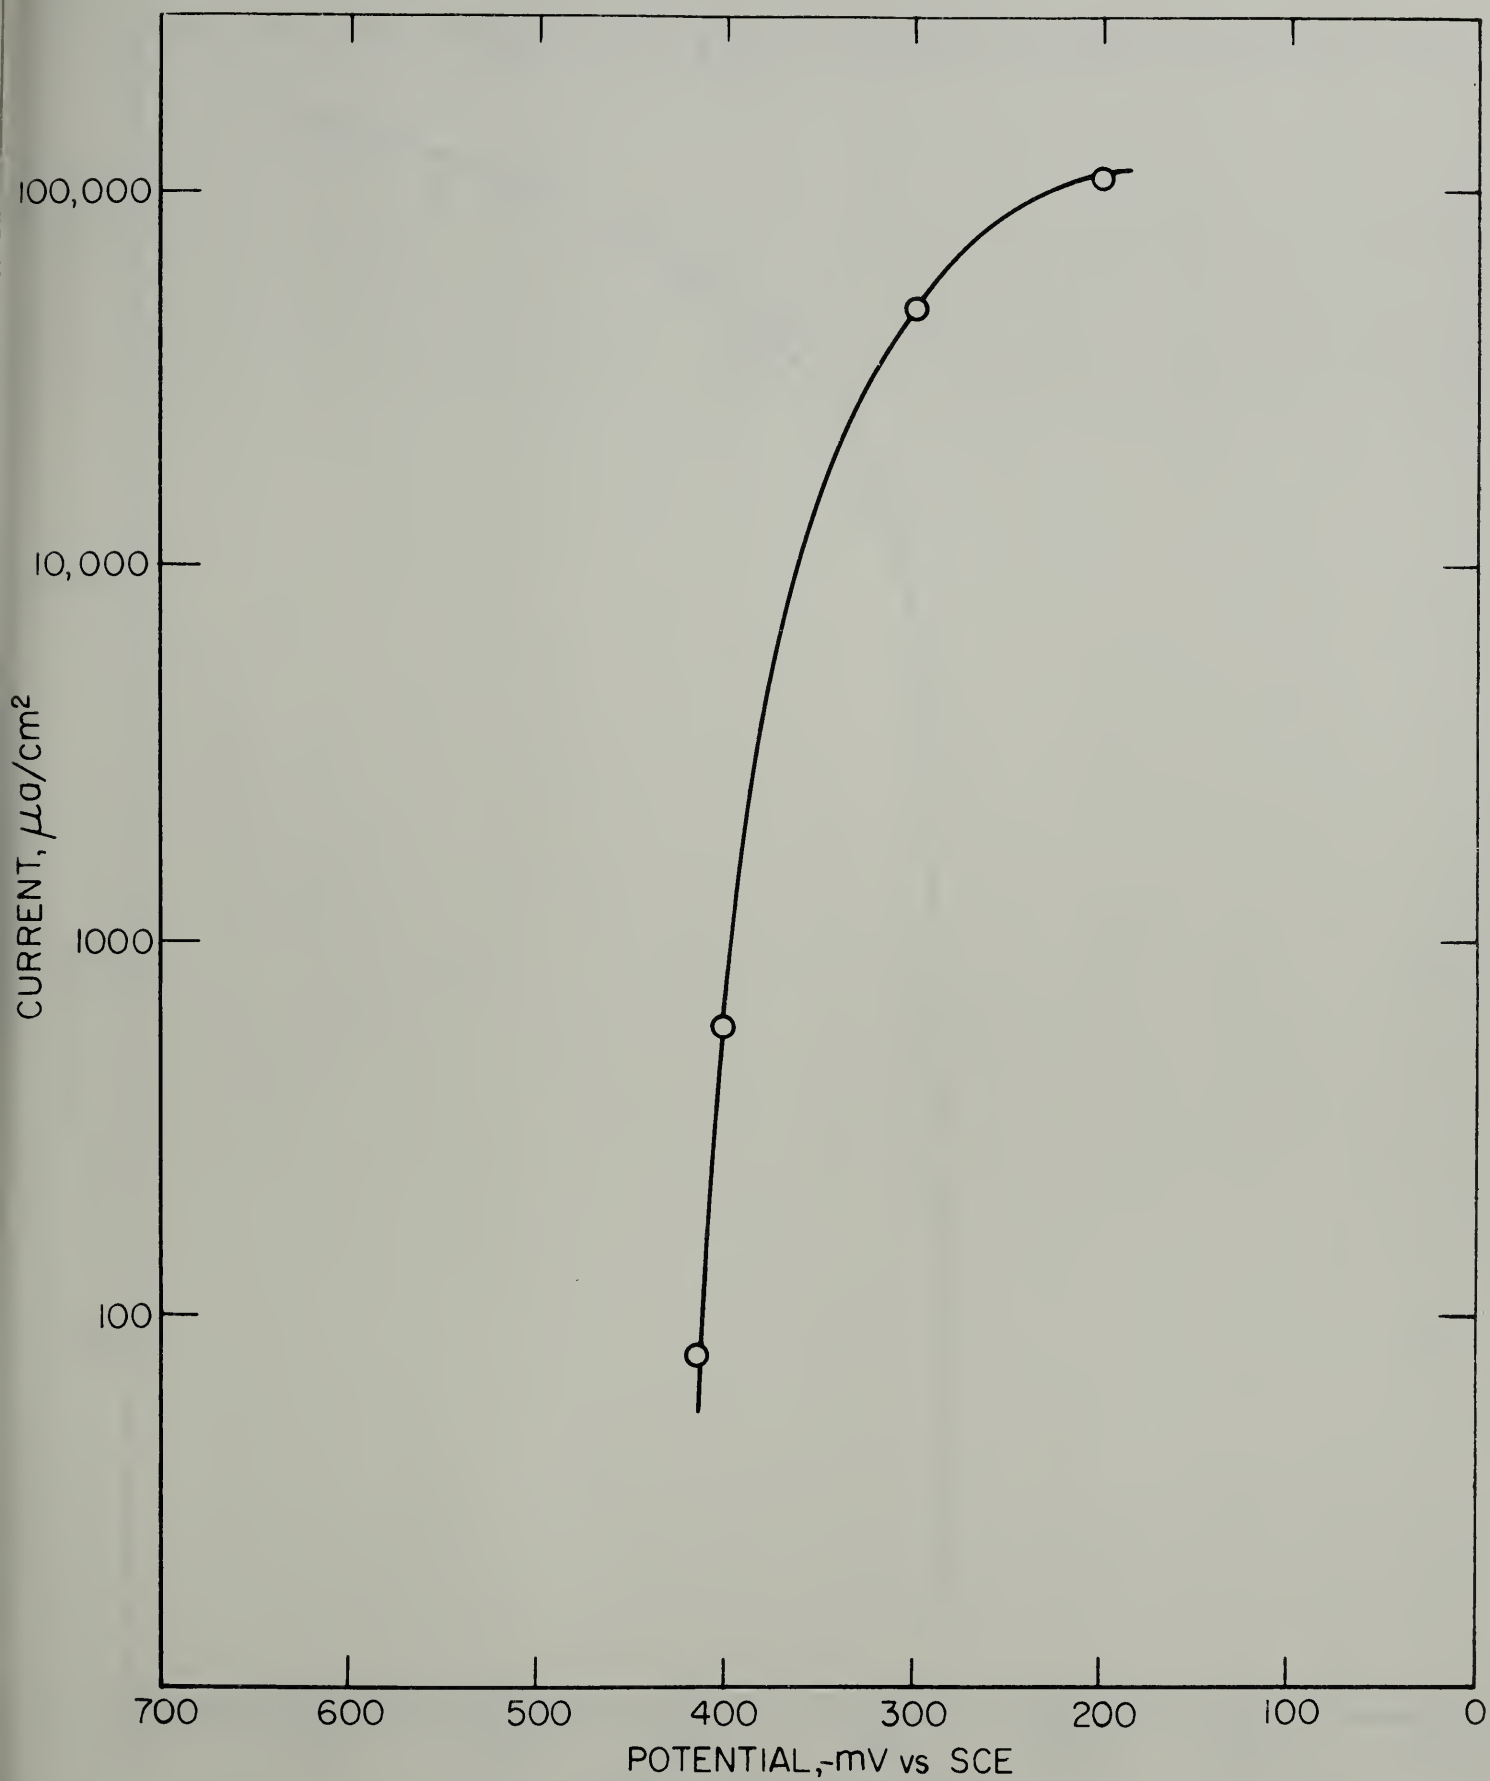
FIGURE 7. ANODIC POLARIZATION CURVE FOR 7075-T651 IN 0.3% NaCl - 3.0%  $\text{K}_2\text{Cr}_2\text{O}_7$  - 3.0%  $\text{CrO}_3$ .

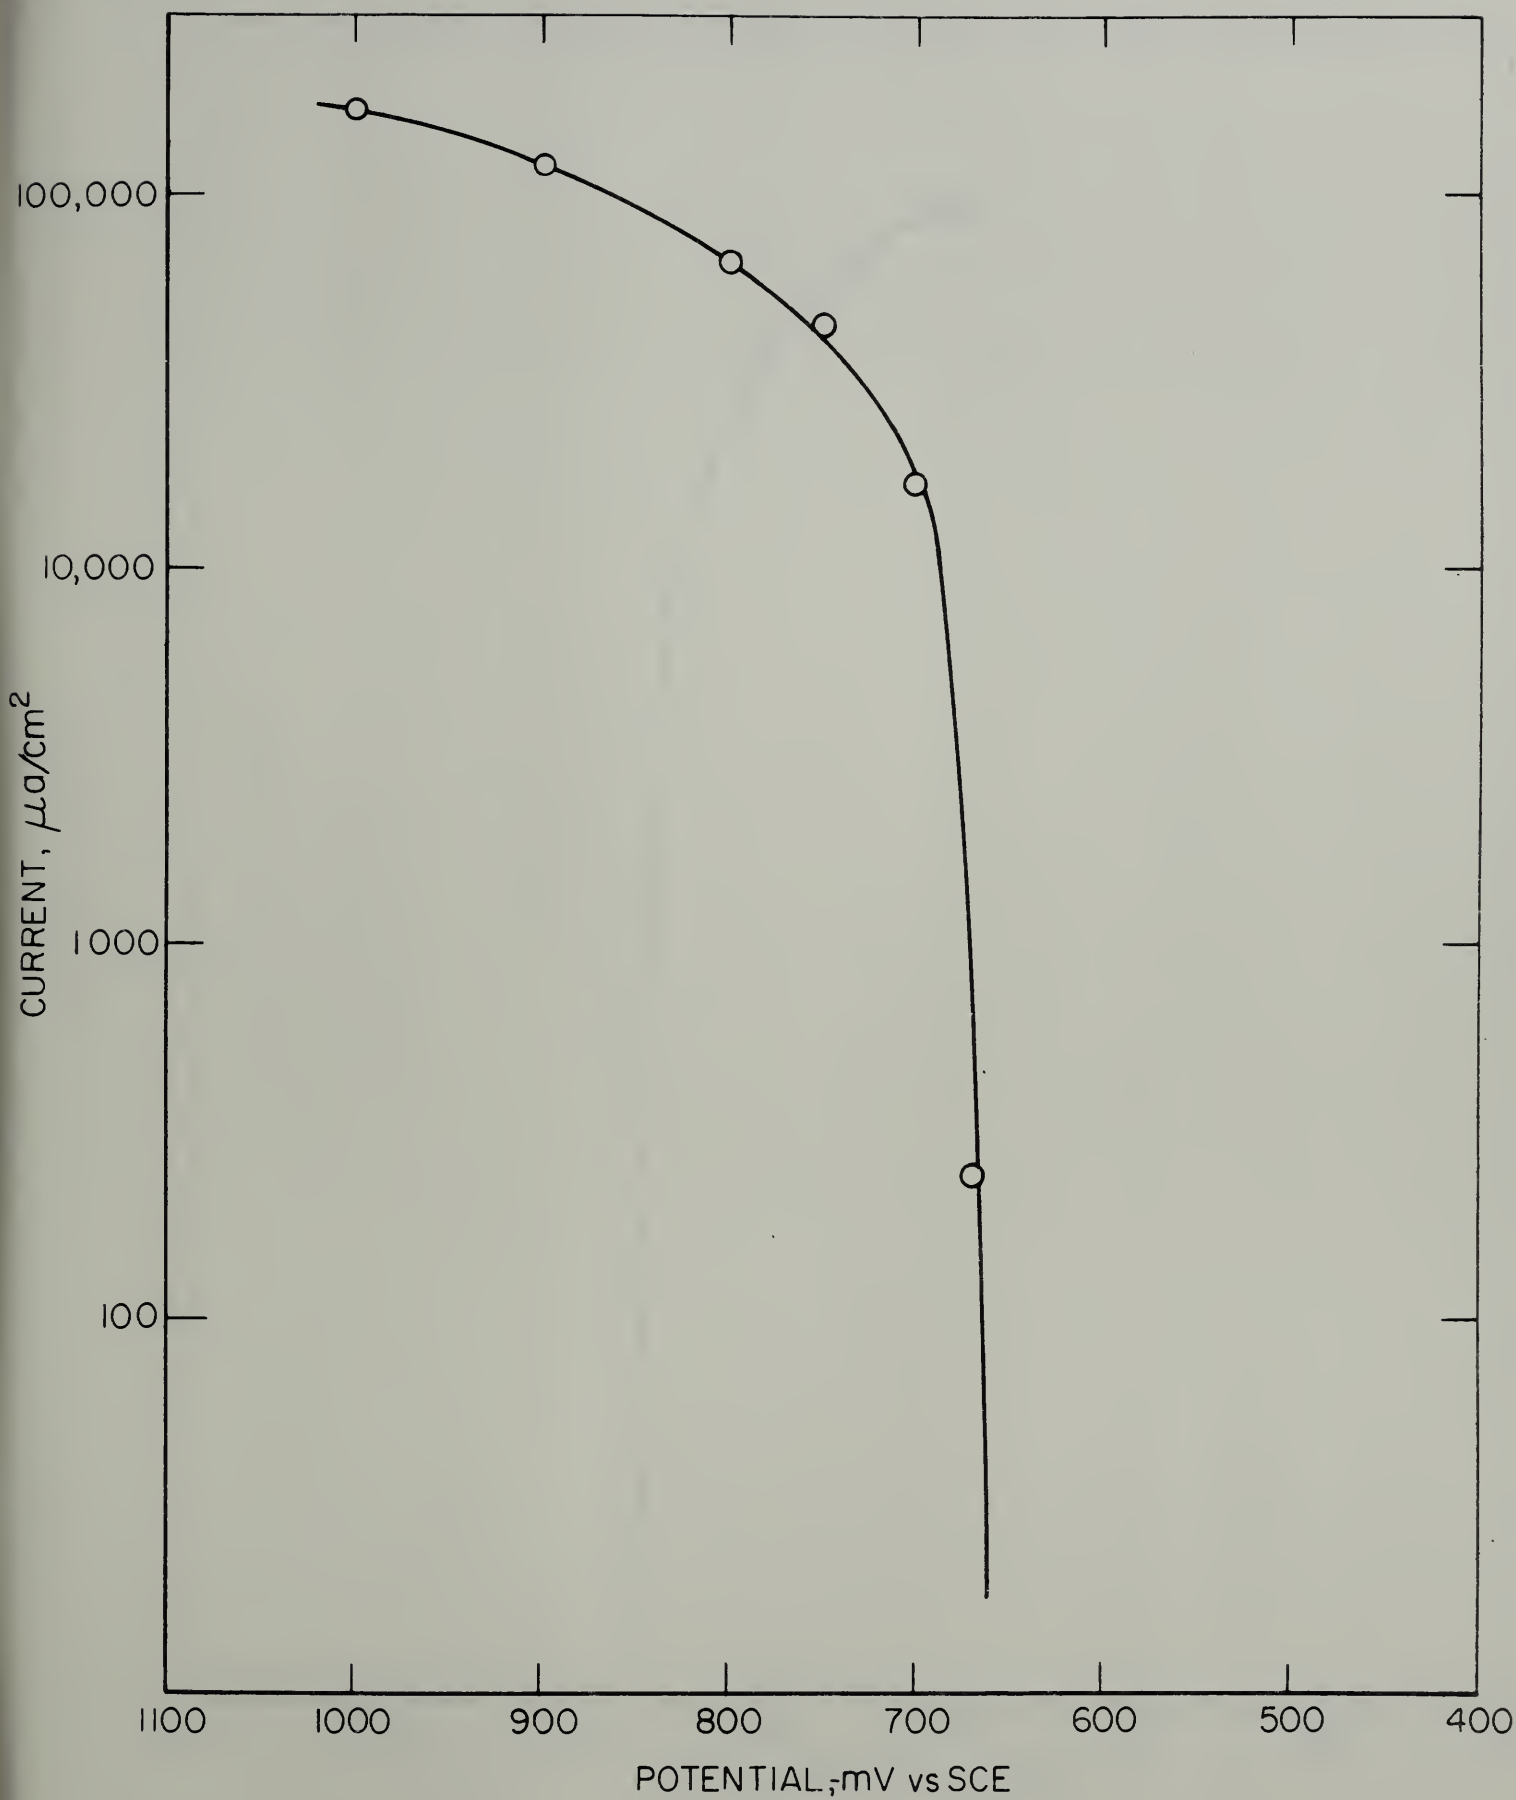
FIGURE 8. CATHODIC POLARIZATION CURVE FOR 7075-T651 IN 3.5% NaCl (pH = 0.9 WITH HCl). OPEN CIRCUIT EMf = -670 mV vs SCE.

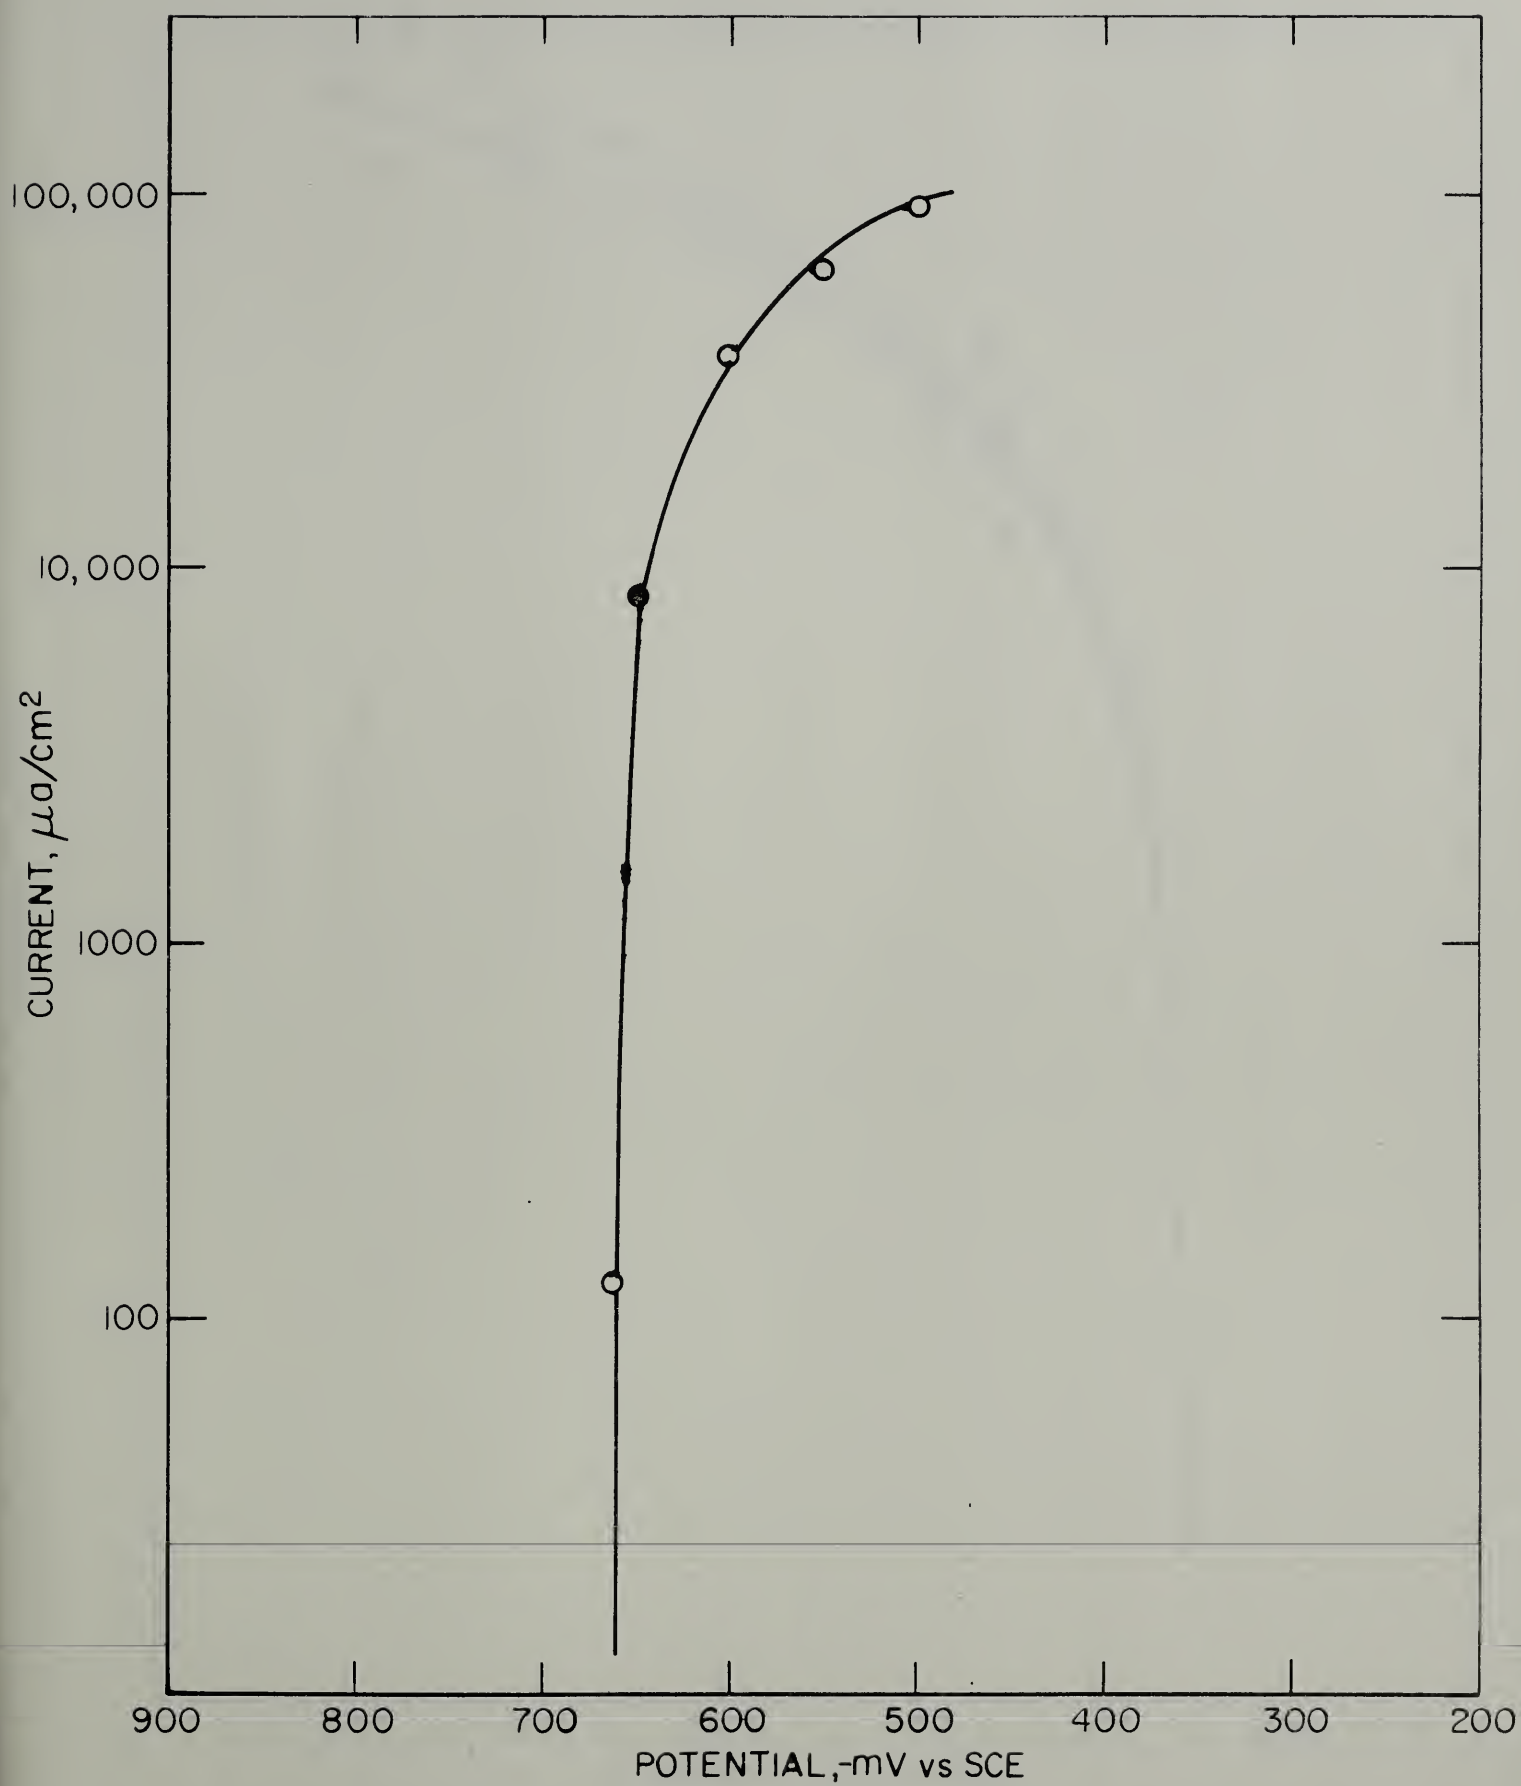
FIGURE 9. ANODIC POLARIZATION CURVE FOR 7075-T651 IN 3.5% NaCl (pH = 0.9 WITH HCl).

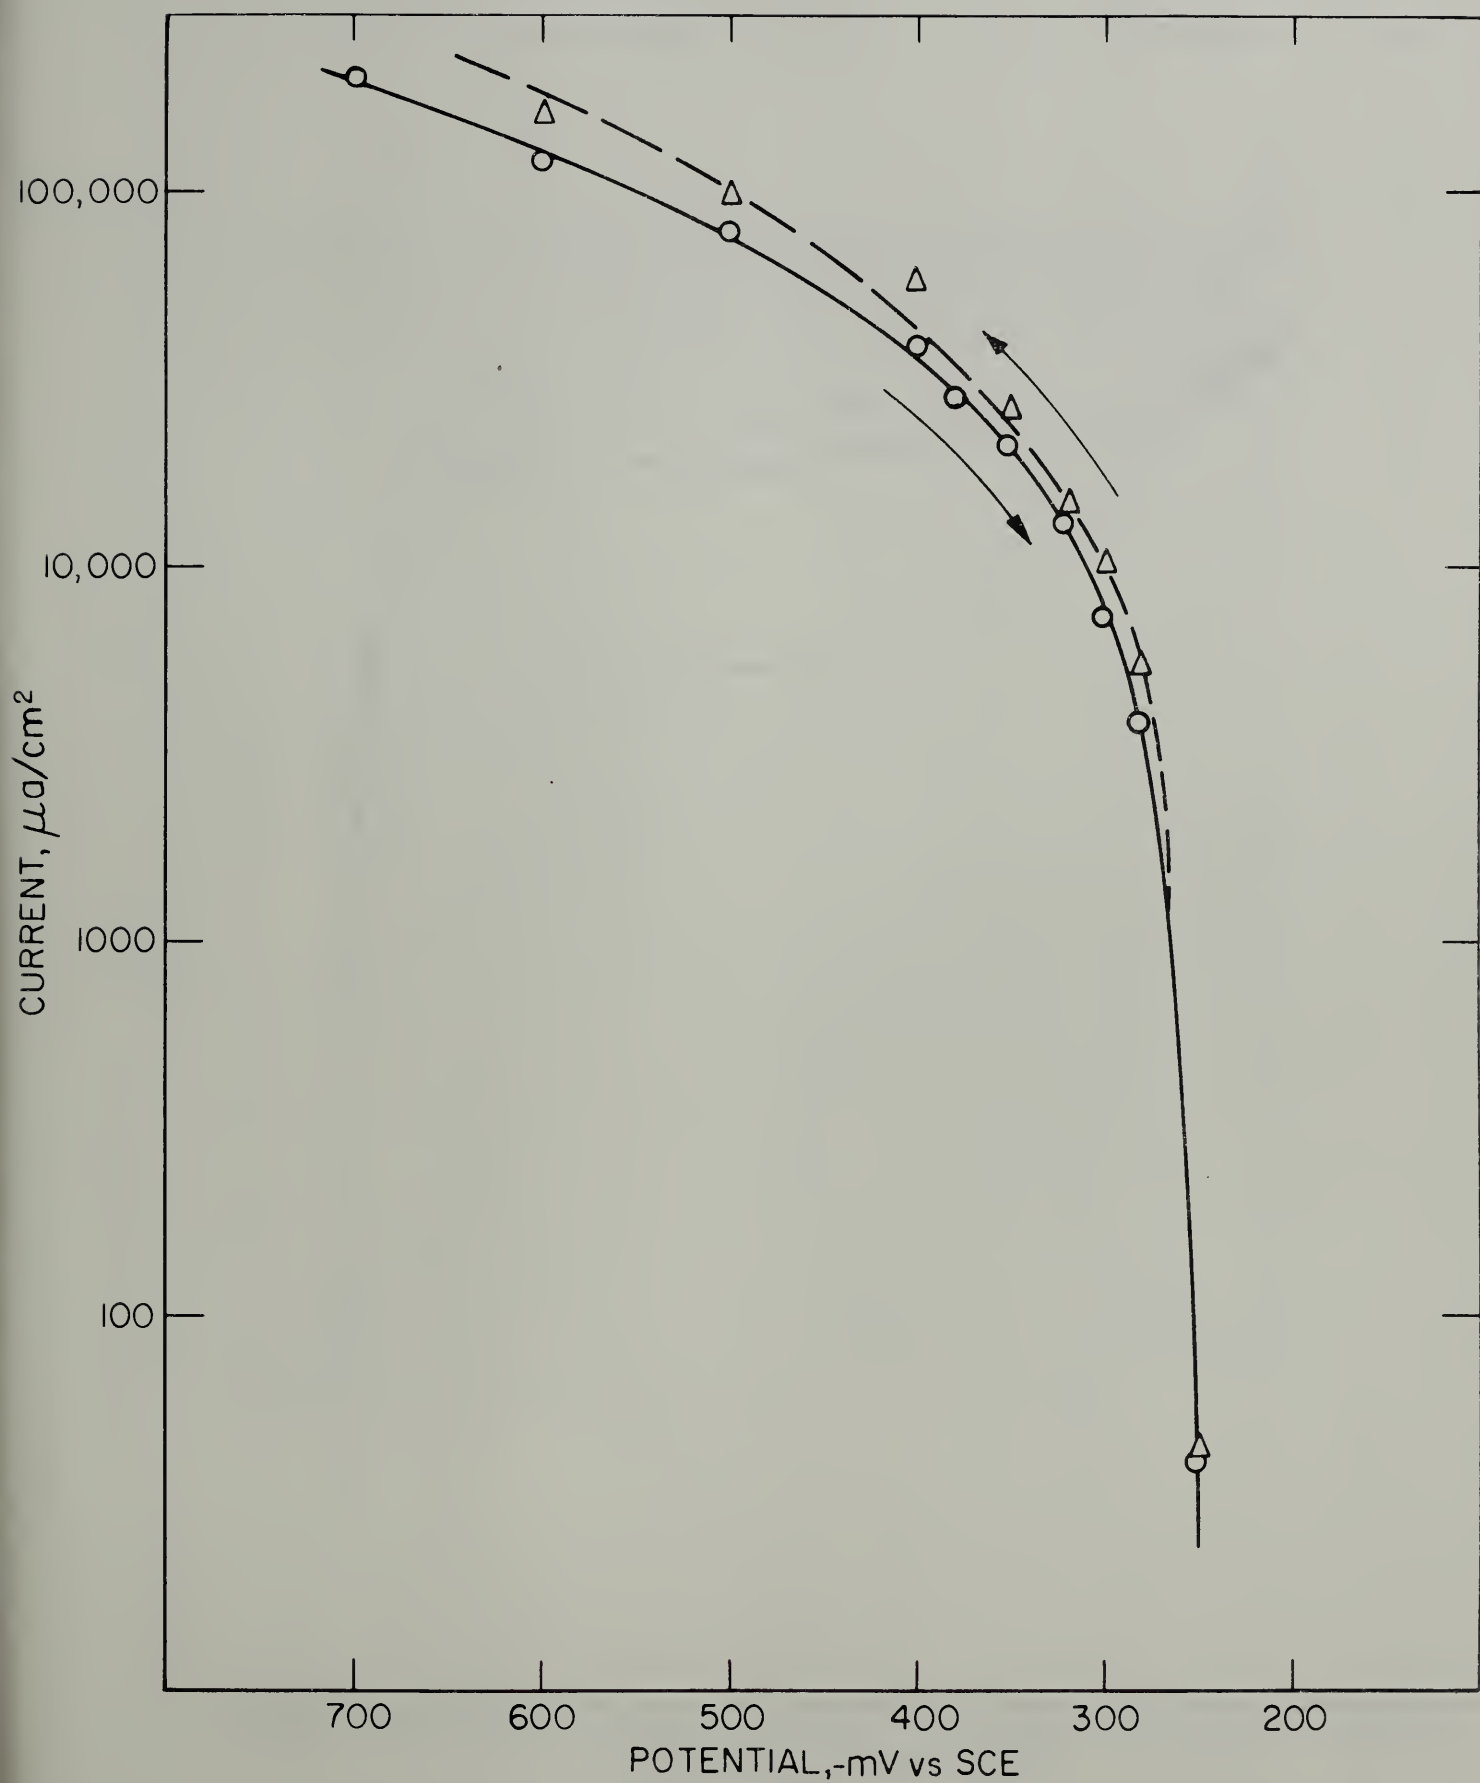
FIGURE 10. CATHODIC POLARIZATION CURVE FOR 7075-T651 IN 1.0N  $\text{NaNO}_3$  (pH = 0.9 WITH  $\text{HNO}_3$ ). OPEN CIRCUIT EMF = -260 mV vs SCE.

The anodic nitrate curve shows a definite break, and this can be interpreted as being related to the formation of a passive film. This break occurs at approximately +400 mV vs SCE and, as this curve shows, is a more well-behaved system. Efforts will be concentrated on looking at the role of film breakdown and directionality for this system where chloride ions can be added in small increments. This way, the onset of breakdown can then be related to cracking.
